Appendix B.1 - Russian River

Case Study Name: Russian River Benthic HCB 2015

Appendix B.2 - Zion National Park, UT

Appendix B.3 - Lake Travis, TX

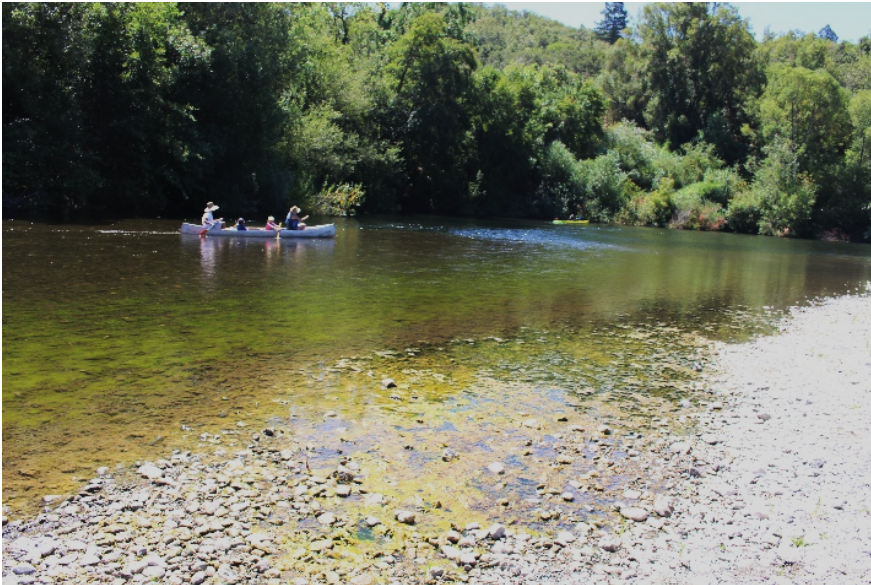
Figure B.1- 2. Recreators travel downstream in a canoe passing a mixed assemblage of benthic algae and cyanobacteria in the Russian River.

Though other cyanotoxin-related illnesses have occurred since 2015 in Sonoma County, no sweeping closure of a water body has been necessary. With response and communication plans in place, and increased agency and private-sector knowledge about cyanotoxins, more tailored communication takes place, depending on the context of the cyanobacterial event. Additionally, there is more communication and educational resources provided to the public. Water quality and health agencies continue to develop and improve their response to cyanotoxins in the watershed to ensure safe recreational opportunities in the Russian River and North Coast Region (Figures B.1-1 and B.1-2).

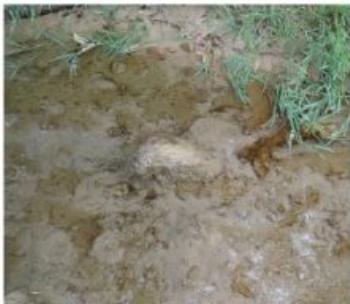
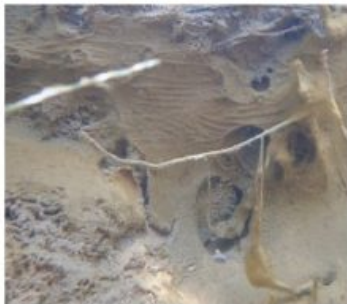
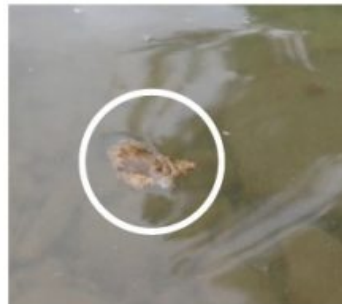
Figure B.2- 2. Warning sign used at Zion National Park.

Algal mats can be attached to the bottom, detached and floating in the water, or growing near the river edge

- Initially, Zion NP had HCB advisory signage that did not show photos of the benthic HCBs. Therefore, the public became fearful of harmless filamentous green algae or only looked for typical morphologies of planktonic HCBs, such as blue-green pea soup-colored water. It became clear to the park staff that visitors need to be shown what the benthic HCB looks like up close and where they are typically found in the river, because benthic HCBs can be cryptic. Zion NP staff reworked their advisory signage to reflect more closely California’s benthic HCB signage showing photos of the benthic HCBs. In addition to Figure B.2-2, Zion NP’s current signage can be found in [Section 5](#).

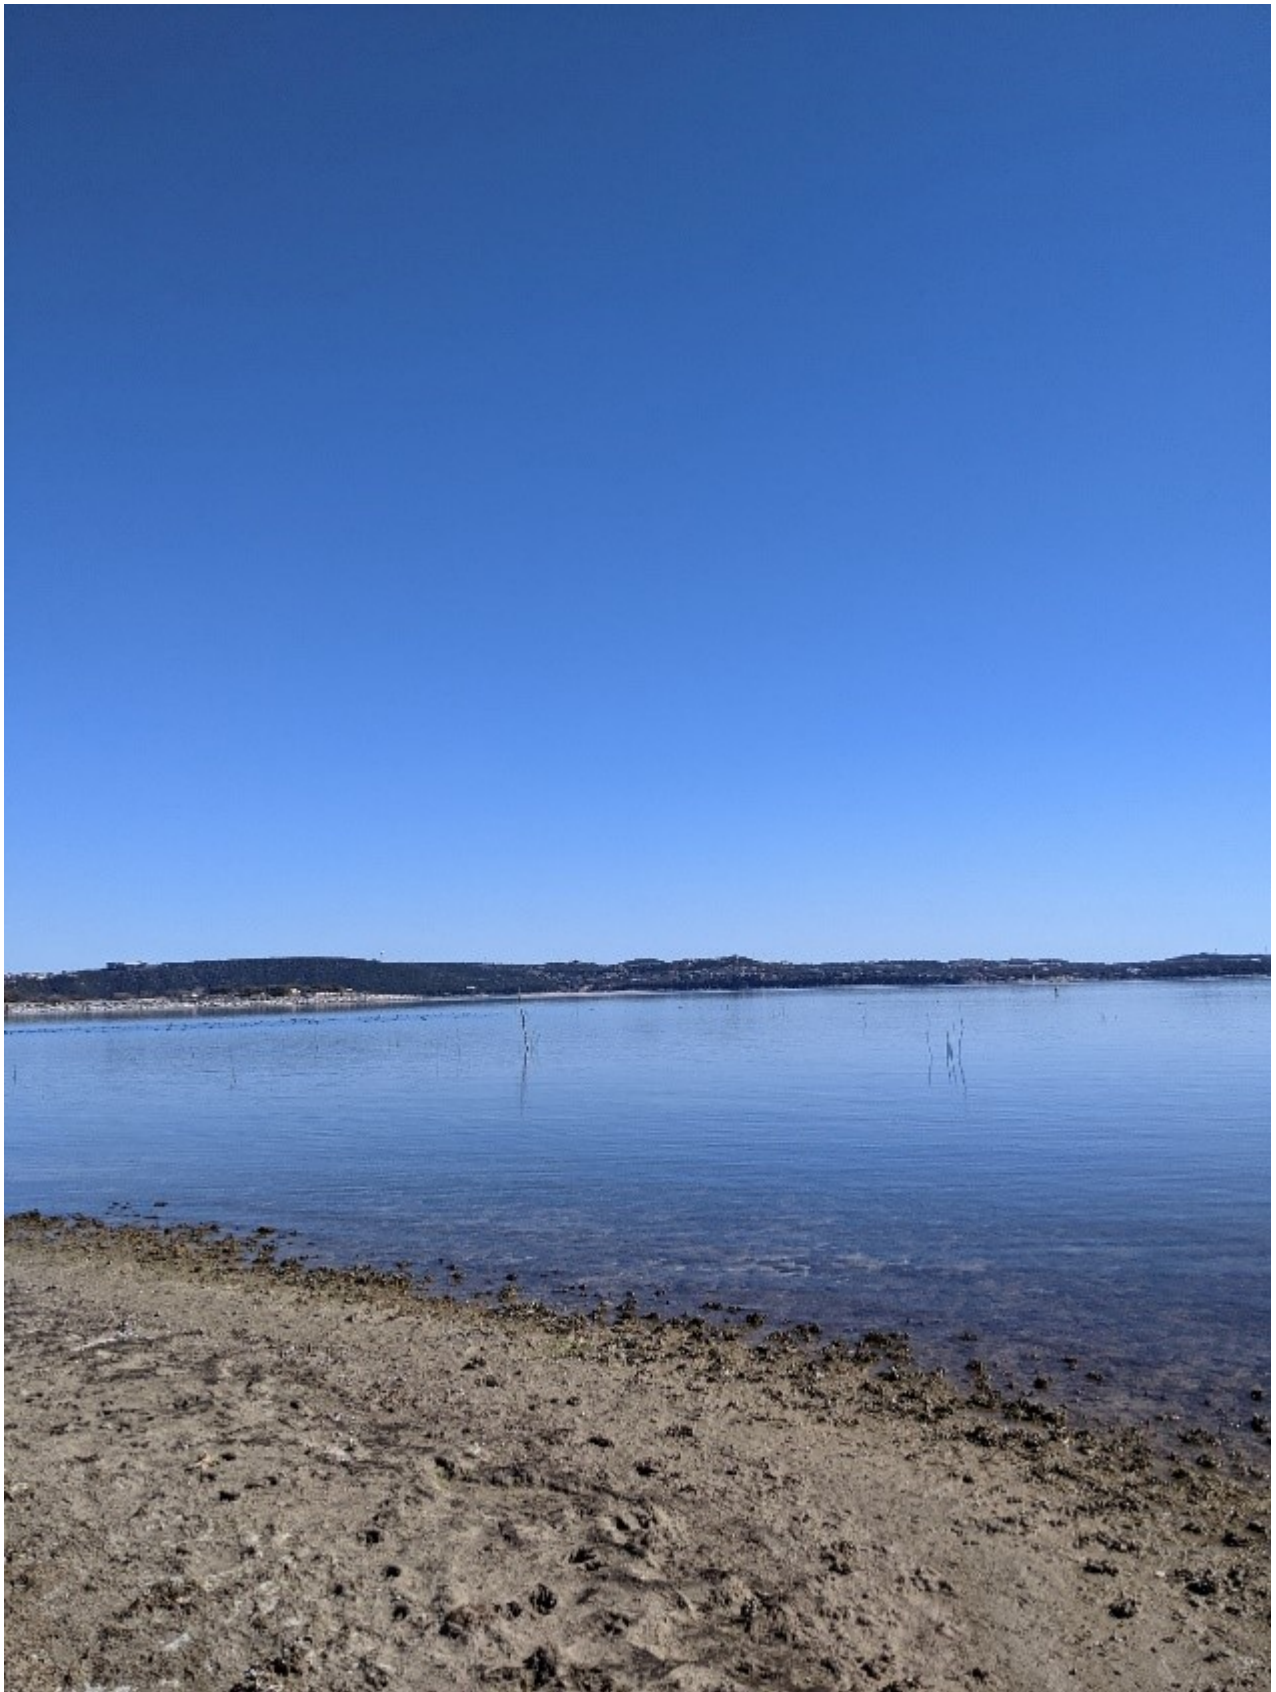
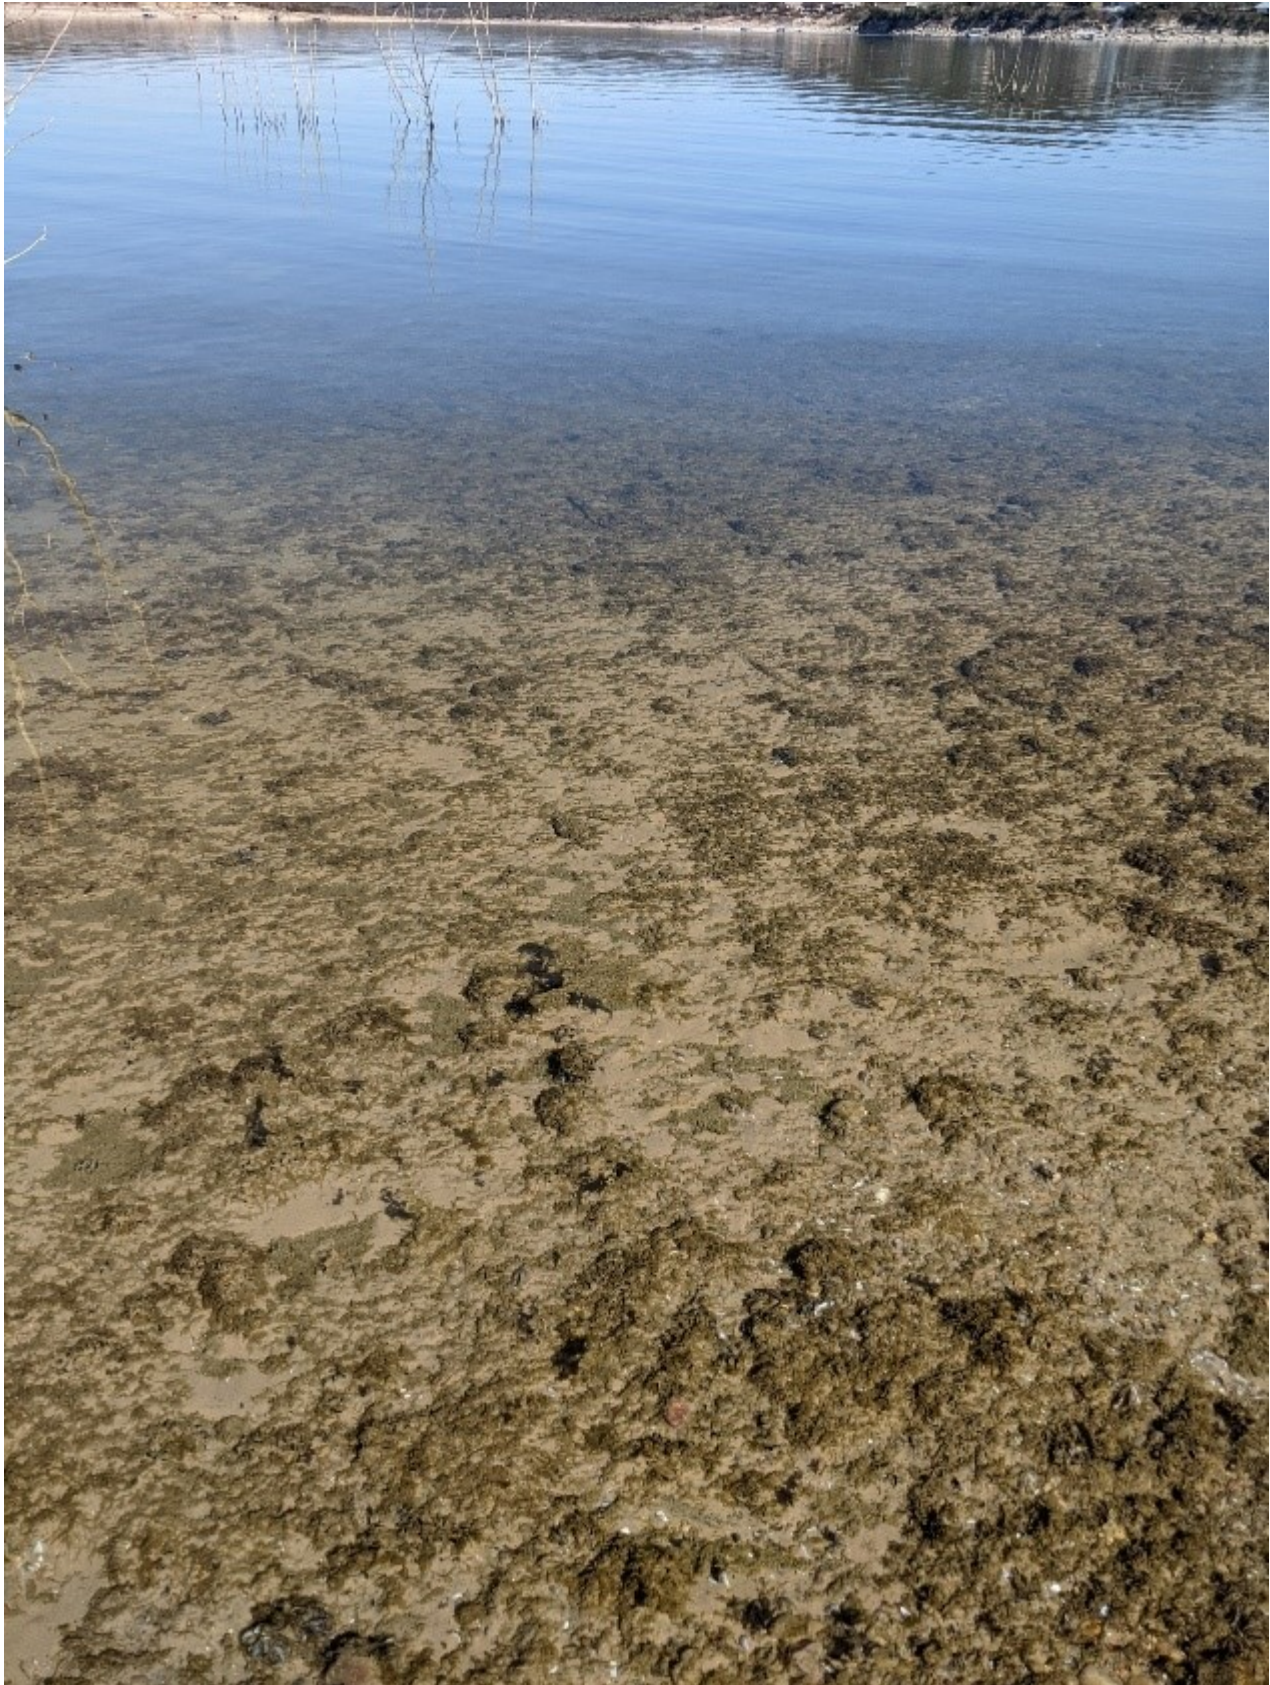
Figure B.3- 2. Photos taken on February 22, 2021, from the initial site on Lake Travis where C1 died on February 20, 2021. There were no visual signs, smells, or other evidence of a planktonic or cyanobacterial bloom at the time these photos were taken.

LCRA collected a composite sample of algae and water material and sent it to GreenWater Laboratories, located in Palatka, Florida. LCRA's assessment of the site gave no visual indication of a planktonic bloom or cyanobacterial bloom (Figure B.3-2). Beginning February 11, 2021, central Texas experienced a winter event causing temperatures to range from 3 to -17

°C (37 to 0 °F) for 8 days prior to the death of C₁. Due to the time of year (winter), the unusual circumstances of the winter event, and the lack of any visible evidence of a bloom, LCRA and the pet owner cooperated to order a necropsy of C₁. The necropsy was performed by Texas A&M Veterinary Medical Diagnostic Laboratory in College Station, Texas, on February 24, 2021. Several tests were ordered, including botulism A, B, and C; drug screen; and a pesticide screen. Stomach content was tested for saxitoxin, cylindrospermopsin, microcystin, and anatoxin-a (ATX). Additionally, digestive tissues (jejunum, duodenum, and stomach content fluid) were sent to Dr. Schonna Manning's laboratory at the University of Texas at Austin, for HPLC-MS analysis of the anatoxin-a congener dihydroanatoxin-a (dhATX). Results showed that trace amounts of anatoxin-a were present in the stomach of C₁, while high levels of the congener, dhATX, were found in multiple digestive tissues, including duodenum tissues (average of 10.51 ng/g DW, n = 2), jejunum tissue (average of 6.076 ng/g DW, n = 2), and from mixed stomach content (average of 974.88 ng/g DW, n = 2).
